# RESEARCH, DEVELOPMENT and TECHNOLOGY TRANSFER QUARTERLY PROGRESS REPORT (QPR)

Wisconsin Department of Transportation (WisDOT)  
DT1241 5/2014

The current WisDOT Bridge Manual recommends using “pervious” granular backfill behind bridge abutments to prevent lateral water pressures on the abutment walls. The granular backfill material is considered “pervious” or “free-draining” based on its grain-size distribution properties. However, the “free-draining” assumption of granular backfill does not properly consider:

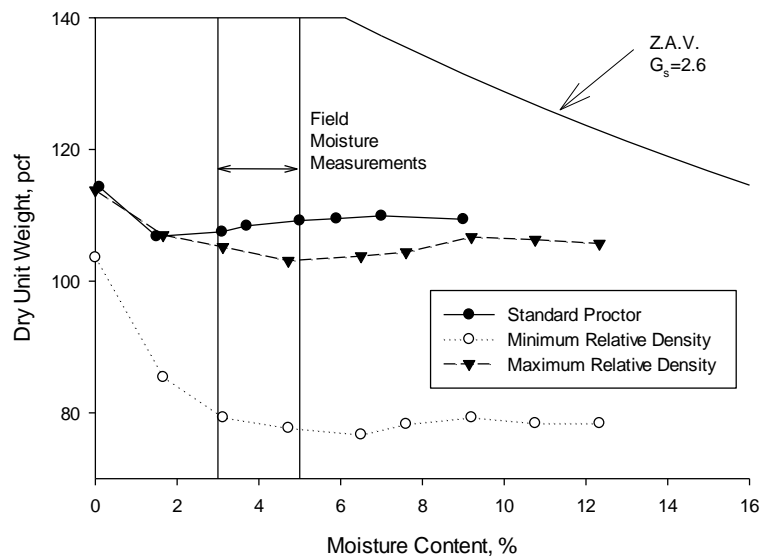
Figure 2. Proctor and vibratory table compaction test results for structure backfill obtained from SH79 bridge project in Boyceville, WI

Proctor and vibratory compaction table tests on structure backfill material from SH79 project are shown in Figure 2. The material showed the highest dry unit weight at 0% moisture content (oven-dried) with a bulking moisture content at about

2% using Proctor compaction method and about 4% using the vibratory method. The field moisture contents of the material were about 3 to 5%, which fall close to the bulking moisture content. This finding has consequence as materials tend to collapse/settle during any post-construction wetting, if the material is placed at bulking moisture content. Collapse tests are underway to characterize the materials' collapse potential due to wetting as a function of moisture content and dry unit weight.

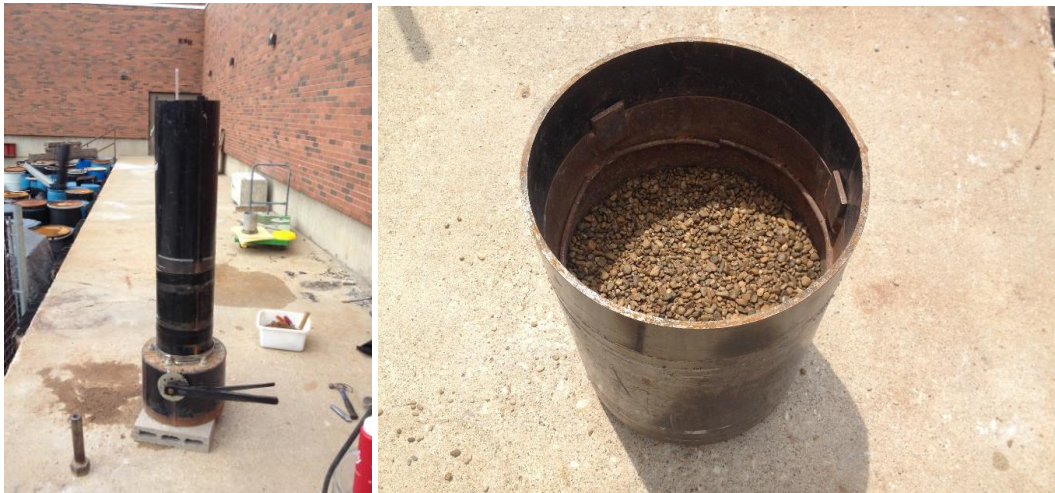
Figure 3. Vertical permeability test setup with pea gravel placed at the bottom of the sample

A picture of the large scale compaction mold permeameter is shown in Figure 3. This setup is used instead of a standard small scale compaction mold permeameter (typically setup with 4 in. or 6 in. diameter) because the standard ones have outflow capacities lower than the outflow capacities of the testing material due to small outlet opening size and relatively less permeable porous stone. The large scale setup is specifically designed to test highly permeable granular materials with large pore size openings in the bottom of the mold. In this testing, pea gravel was placed in the bottom 6 in. of the compaction mold (which has a coefficient of permeability of  $k > 100$  cm/s). Structure backfill was placed above the pea gravel by placing a non-woven geofabric at the interface to minimize migration of fines from the backfill material. The material was placed in thin lifts at in situ moisture content (about 5%) to compact to a target 95% of maximum Proctor density. Pictures of compaction mold after sample is compacted and after permeability test are shown in Figure 4. Tests were conducted at water pressure heads ranging from 28 in. (70 cm) to 12 in. (30 cm) above the bottom of the sample at several times after the test is started. The time delay tests were performed to assess changes in  $k$  values due to clogging of the non-woven fabric material placed beneath the sample. Results are presented in Figure 5, which indicated that the  $k$  values decreased with time. The fabric beneath the sample was tested after permeability testing, which indicated that about 3.4% of the total dry weight of the material was migrated into the fabric. The field  $k$  value measured on the site was about one order of magnitude higher than in the lab – this is likely because of the higher densities measured in the lab (~93% compaction) than in the field. The material in the field was relatively loose. Additional tests are planned with tests conducted at 85% and 90% target relative compaction.

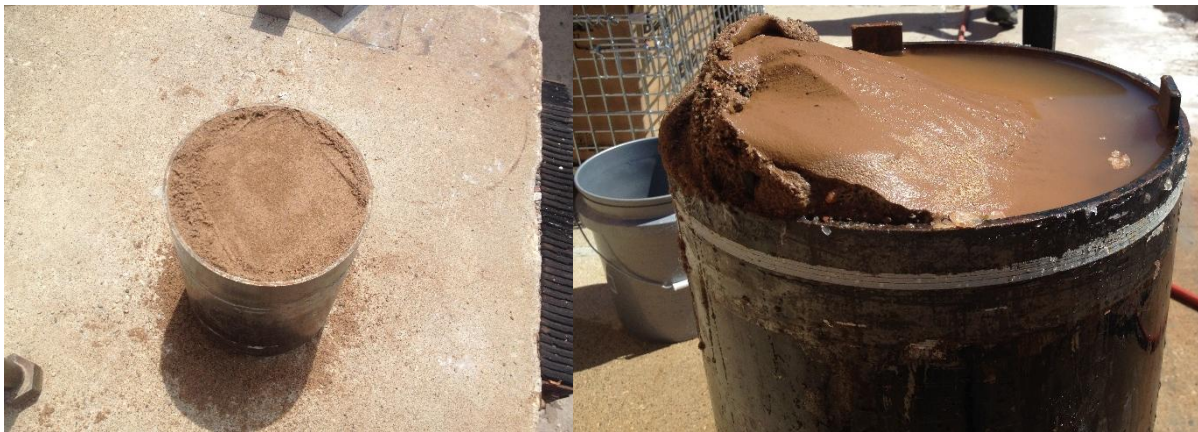
Figure 4. Granular backfill before (left) and after (right) vertical permeability test

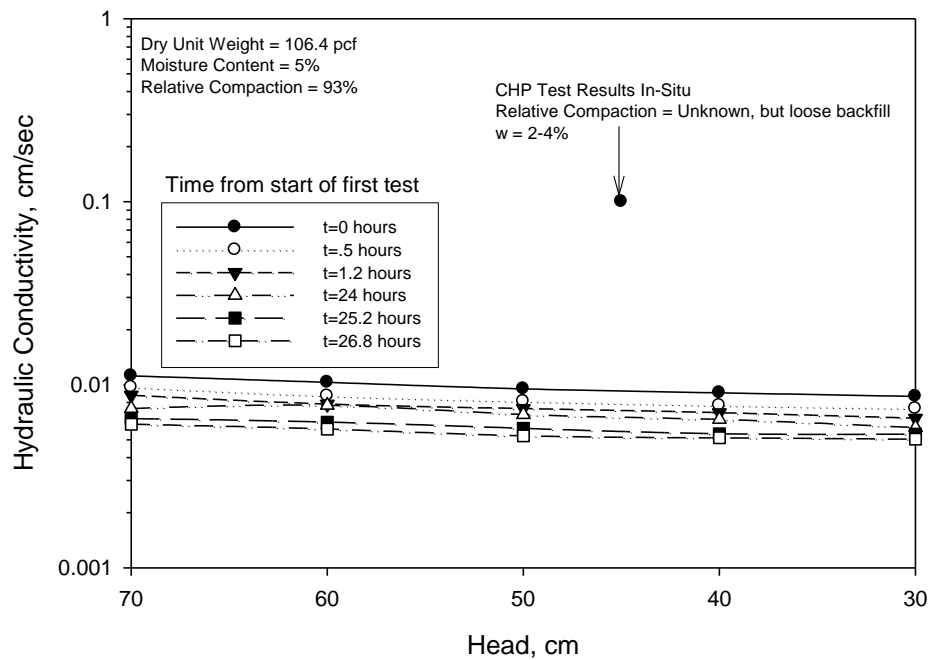
Figure 5. Vertical permeability test results for granular backfill from SH79 bridge near Boyceville, WI

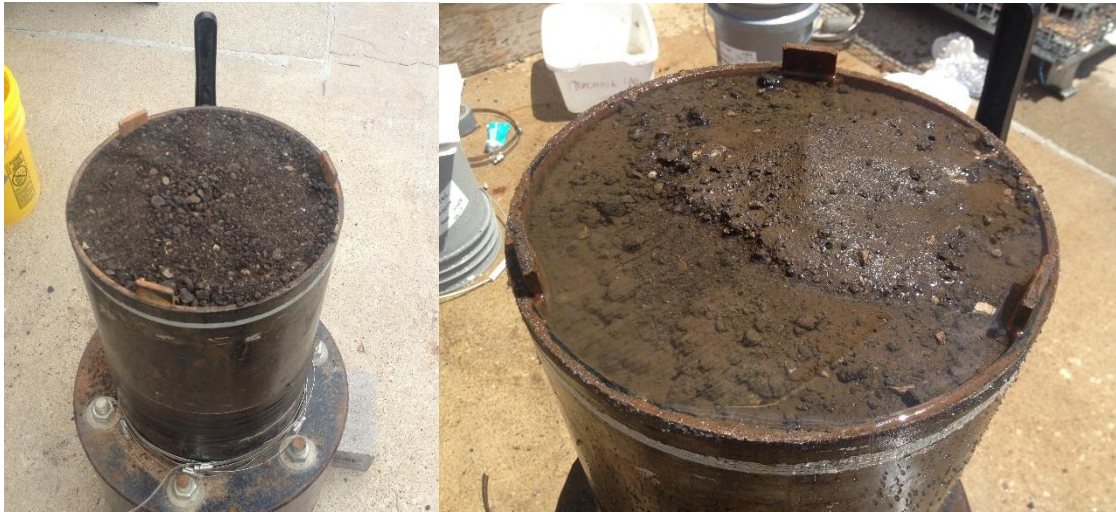
**Figure 6. RAP before (right) and after (left) vertical permeability test**

Vertical permeability tests on RAP material were also conducted (Figure 6) and the results are presented in Figure 7. The RAP material also showed a decrease in  $k$  value with time, by nearly one order of magnitude within 24 hours of the first test. Testing on the fabric material indicated that about 7.2% of the total dry weight of the material was migrated into the fabric.

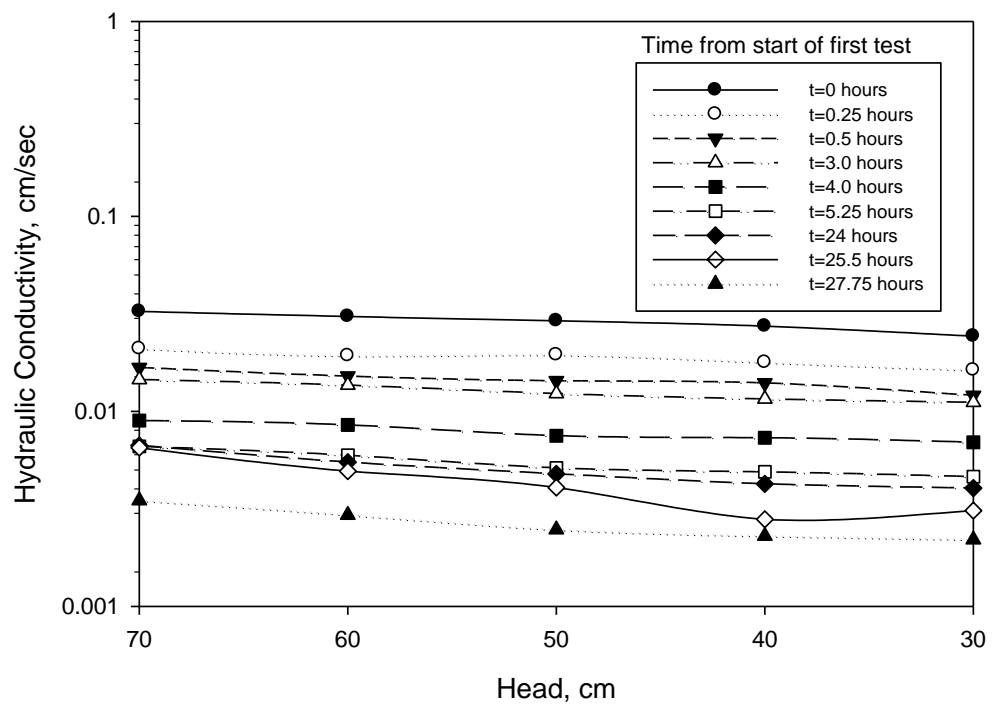
**Figure 7. Vertical permeability test results for Manatts RAP**

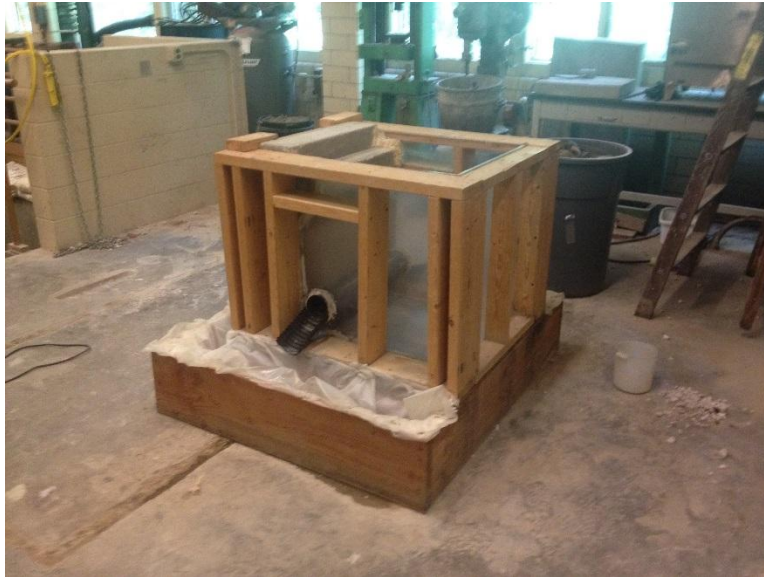
**Figure 8. Cleaned out abutment model**

The bridge abutment model fabricated at ISU is modified and prepared for testing for this project (Figure 8). Dynamic pore pressure sensors have been purchased from Geokon for instrumentation in the bridge abutment model. These sensors will be installed into the abutment model to assess pore pressure dissipation over time on different structure backfill materials obtained from the project sites. This values obtained from this model will be used to calibrate numerical analysis results using Geostudio SEEP/W.
